Fractured tuber coxae of the ileum

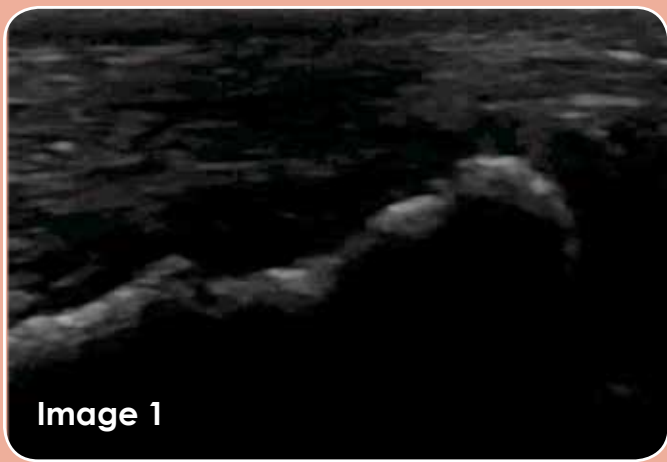
Image 1
Longitudinal image of the caudal aspect of the right (normal) tuber coxae. Proximal is to the left.

This horse had a history of blunt trauma to the left tuber coxae, several months previously. The bone surface of the lateral aspect of a normal tuber coxae can appear somewhat irregular, but contiguous, on ultrasonography (Image 1, right tuber coxae). There is loss of continuity of the surface of the caudal aspect of the left tuber coxae in multiple locations, consistent with a comminuted fracture (arrowheads, Image 2,3). There is organised fibrous tissue located superficially, adjacent to the location of the fracture (*, Image 3).

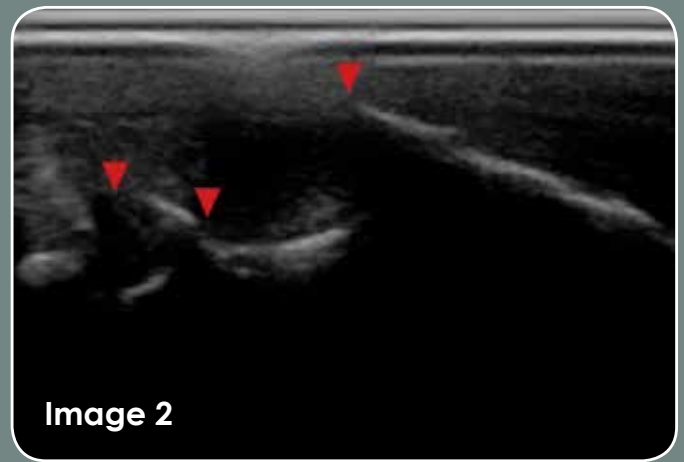
Image 2
Longitudinal image of the caudal aspect of the left tuber coxae. Proximal is to the left. There is disruption to the bone contour in several locations (arrowheads).

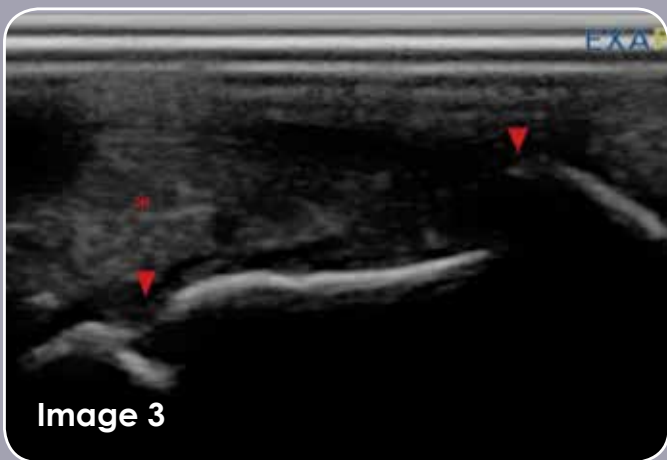
Image 3
Longitudinal image of the caudal aspect of the left tuber coxae. Proximal is to the left. There is disruption of the bone contour (arrowheads). *= organised fibrous tissue.
